METAL CRAFT REPAIR, TREATMENT AND
MAINTENANCE PLAN PROJECT

SALEM PIONEER CEMETERY

APRIL 20, 2018

A REPORT ON EXISTING CONDITIONS TOGETHER WITH NEEDED REPAIRS, TREATMENT RECOMMENDATIONS, & LONG-TERM MAINTENANCE GUIDANCE FOR THE CITY OF SALEM PARKS AND RECREATION SERVICES PUBLIC WORKS DEPARTMENT

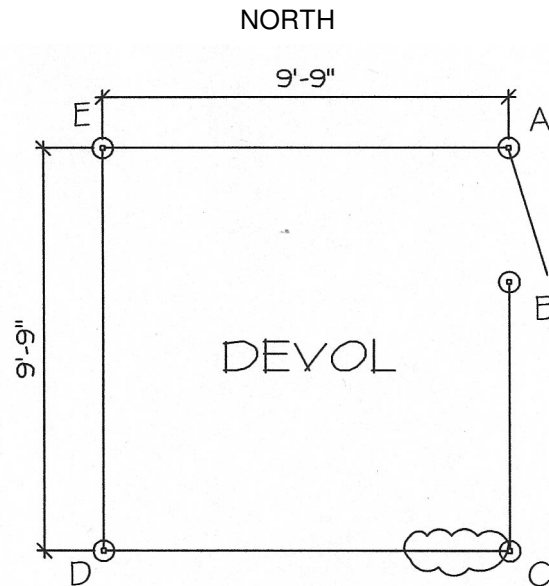
- The enclosure is damaged from being hit at the C-D section. This bent out of alignment, the top and bottom rails, and broke (2) panels [one is missing]. The rail pieces should be able to be suitably straightened, if not, they need to be re-fabricated.

- Replace (2) panels where indicated on diagram. These appear to be available and in stock from Lawler Foundry in Alabama; Pattern #8658.
- Posts A & D have base plates with portions broken off. These can be mended with newly fabricated material. Post A needs to be reinstalled.

- Post C has a broken ground mounting plate. This can be mended/replaced.
- The Gate has a broken lower corner that needs repairing. There is no apparent means to latch and secure the gate, This needs to be developed.

- Post and Rail Bolts: New bolts are required at various locations to secure the posts to the ground plates and for rails to posts after repairs are made. Approximately 75% of the small bolts on the rounded top rail piece are rusted out and need replacement. New bolts should be galvanized iron or stainless steel.

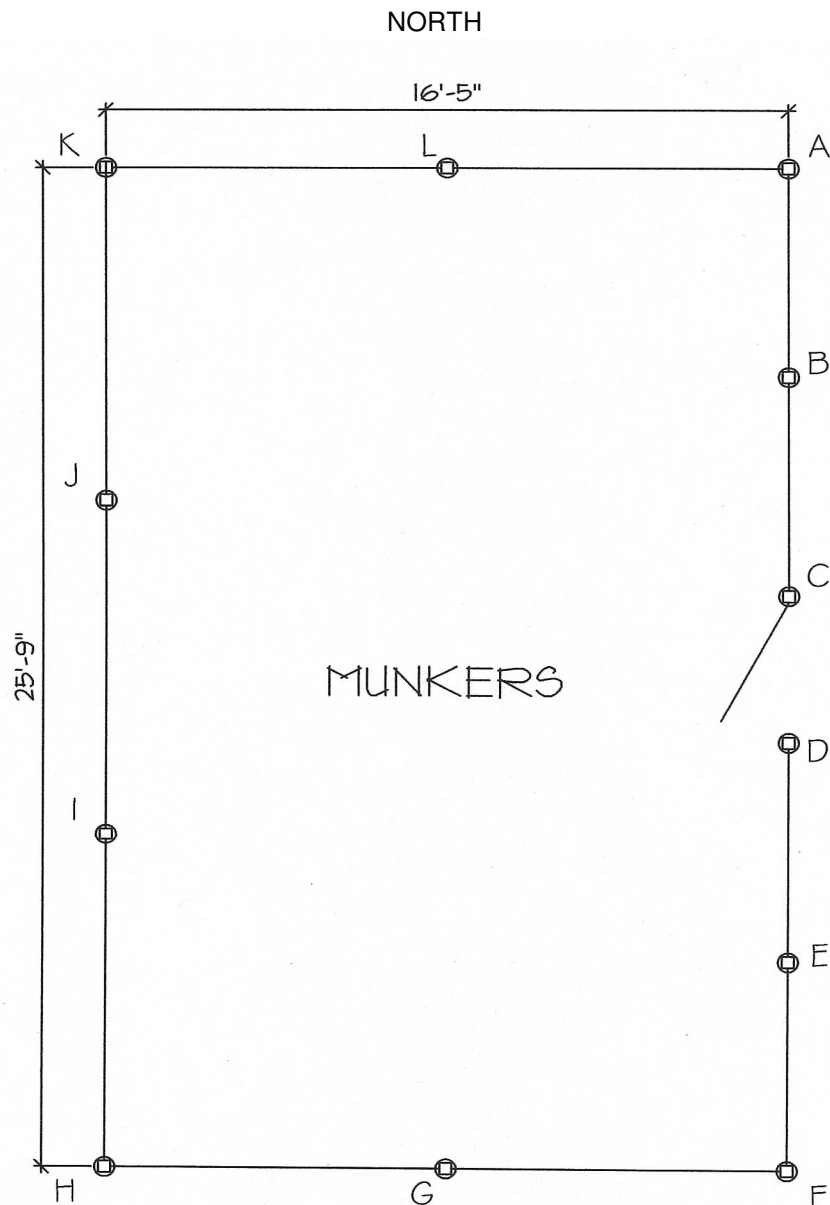
- The enclosure has significant rusting and damage to the cast iron decorative pieces. Rusting makes it not only very difficult to distinguish where one piece joins to another, but also unlikely to disassemble pieces. The AL bay has a bent top pipe rail. The lower rail at GH is disengaged from post H. This might be reconnected or stabilized using an insert.

- Post B is out of alignment; Post F has a break below the lower rail, and is missing its finial; Post I has a damaged finial. Replacement finial might be able to be found, or new ones cast. It might be best to repair the break at Post F by digging out the lower section and footing stone to allow it to move to the existing post location, installing a pipe insert to reconnect the post, and then bury the stone. All post bottoms are under lawn and soil so that their draining weep holes do not function. This makes rain water accumulate in the post with no way to get out. The solution is to remove the soil, open up the drain holes again, and use gravel drain material for the fill.

- Rail Sleeves: Many are broken or missing, 21 of 44 ends and 14 of 22 middles, as inventoried at the following bays:
 - AB: Ends: 3 broken; Middles: 2 broken

- BC: Ends: 3 intact, 1 broken; Middles: both intact
- GH: Ends: 2 broken; Middles: 2 broken
- HI: Ends: 3 broken; Middles: 2 broken
- IJ: Ends: 3 broken; Middles: 2 broken
- JK: Ends: 3 broken; Middles: 2 broken
- KL: Ends: 1 broken, 1 missing; Middles: 2 broken
- LM: Ends: 4 broken; Middles: 2 broken

A source for the broken and missing sleeves or an appropriate mold pattern has not been located. New sleeves would need to be cast from new molds taken from intact pieces.

- Gate: The gate is not functional since the iron tabs on the post and gate used for swinging need repair. The upper tab on the post is broken and the lower tab on the gate is broken. These tabs should be able to be repaired. The design and nature of the infill is not known, possibly something similar to that of the Thompson gate.
- The enclosure is rusted and requires cleaning, paint preparation and finishing.

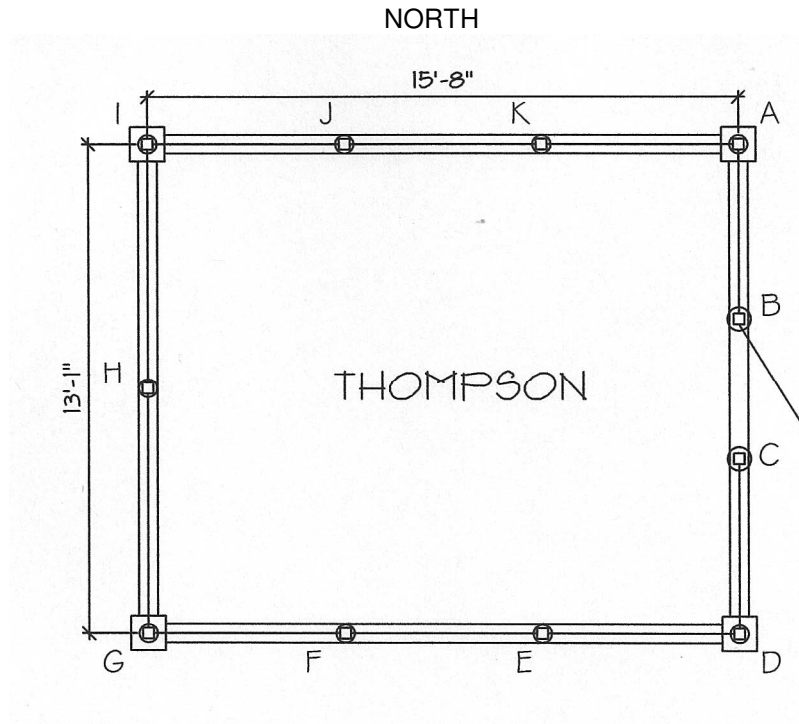
- The enclosure is in much better condition than Munkers. There are damaged members and missing pieces, however.
- Post A is broken and displaced just below the lower rail coupler. The repair will require aligning the lower section that is mounted to the curb corner stone with the coupler and joining with an insert. Inspection reveals that the post anchorage used an inner pipe sleeve embedded in the curbstone with lead used to join it to its cast iron base. There is room to move the stone, but alignment will likely also require force on the iron enclosure.
- There is a crack in the finial at Post D; Post F has a hole in its finial; Post J has a missing finial.
- Rail Sleeves, as inventoried at the following bays:
 - AB: Ends: 1 upper broken; 1 lower cracked
 - GH: Ends: 1 upper broken;
 - JK: Ends: 1 upper broken; 1 lower cracked
 - KL: Ends: 1 upper broken; 1 lower broken

- Gate: The lower gate swing support at Post B is broken off. A replacement support tab should be able to be made. The lower cast iron gate corner is broken and missing. This repair is more challenging and will require a connection to the cross bar.
- NE corner curb stone is displaced. This can be reset in conjunction with the pipe repair.
- The enclosure is rusted and requires cleaning, paint preparation and finishing.

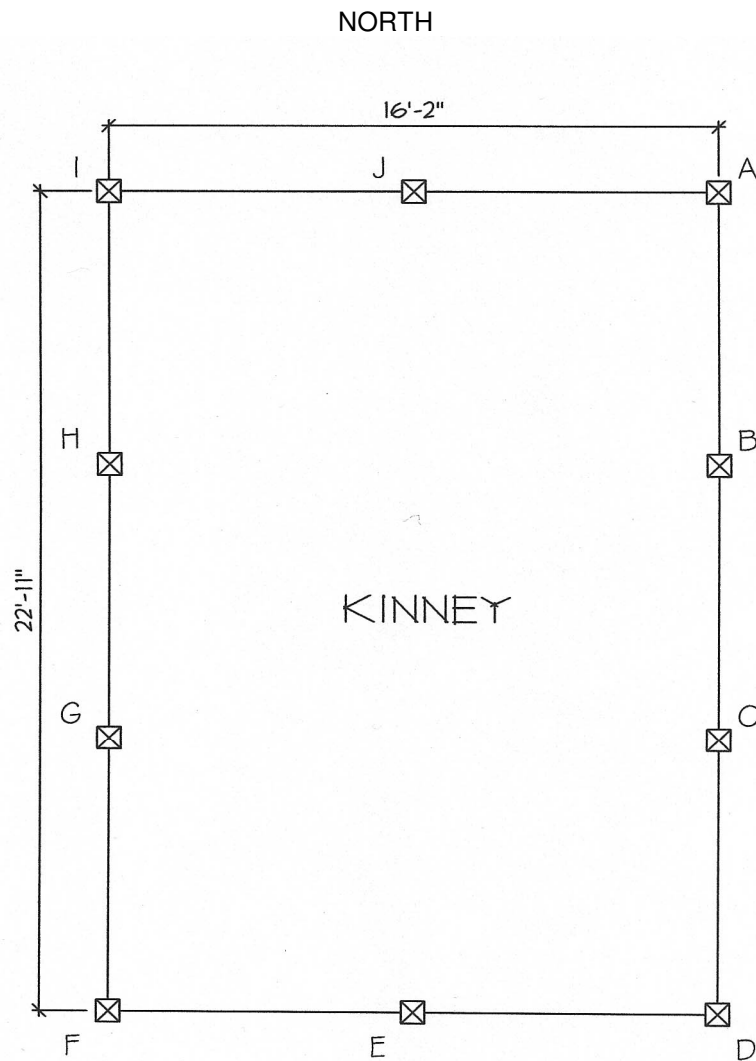
- Upper AB and JA rails are loose at Post A where the top is broken; Lower AB rail is loose at Post B.
- Posts: Stone post A has a clean break at the upper rail. The top can be rejoined to the shaft with mortar, epoxy should not be necessary. First, clean the stone to base material, remove the white lead oxidation from the rail ends. Then, secure the rails with new lead, or a liquid elastomeric material.
- Post E: Weather proof the rail joints with new non-shrink grout or replace with lead per original.
- Finish: The posts are generally in good condition, and need only light cleaning if desired. The rusting on the rails appears stable. See alternatives in the materials discussion section.

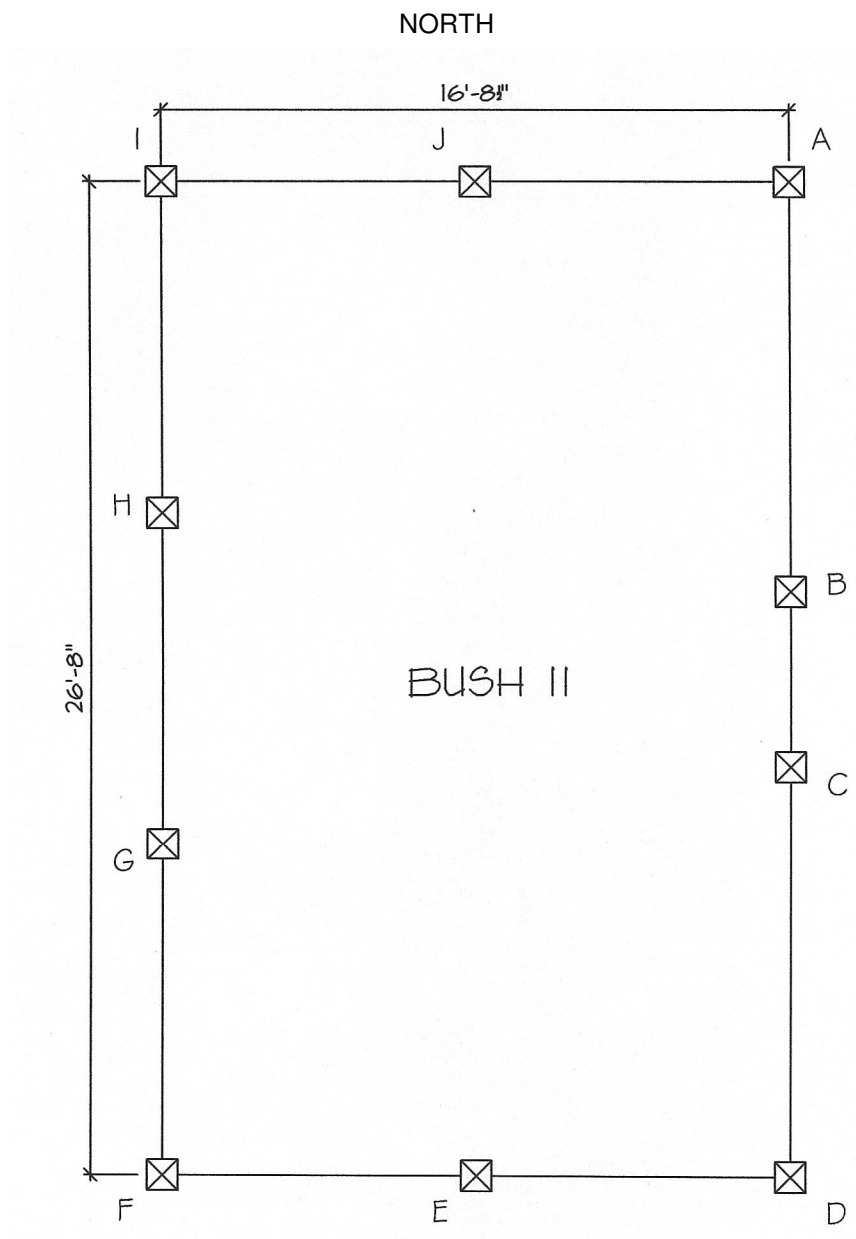
- Middle FG rail is loose at Post G; Lower HJ rail is loose at Post H. The lead at these locations could be reworked to tighten those joints to make waterproof connections
- **Finish:** The posts are generally in good condition, and need only light cleaning if desired. The rusting on the rails appears stable. See alternatives in the materials discussion section.

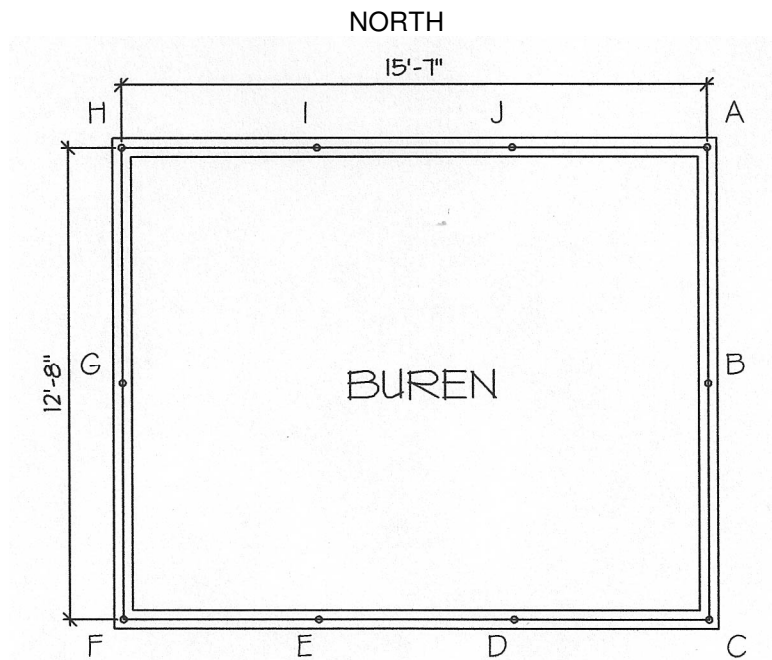
- The rail between Post C and Post F is a little out of plane. It would be difficult to correct the situation.
- Post B is rusted out at its base. Others are also heavily rusted, and in some places rusted through the pipe walls. Connections are rusted heavily. Where completely rusted, the member, or portion of it, could be removed and a new iron section inserted provided the new material matches the size. New welds should be ground flush with existing. If the concrete at the interior of the posts is near the top of curb, weep holes could be drilled into the posts to allow water to drain out. Alternatively, a surface mounted pipe base could be installed.

- Curb: The curb is generally in fair to good condition, but is cracked in several locations due to stresses from the rusting of the embedded pipe posts. This occurs at Posts D & E. At Post J there is a large crack through the curb. The rusting and stress on the curb will continue, unless the pipe section is replaced. Some relief can be achieved by making the iron to exterior concrete joint waterproof. That does not, however, address interior moisture effects. At severely damaged posts and curbs, a section of curb could be removed and new pipe installed with the new concrete curb section as an alternative solution. This curb section could be doweled into the existing concrete curbs for future stability.

- The railing enclosure is rusted and requires cleaning, paint preparation and finishing.

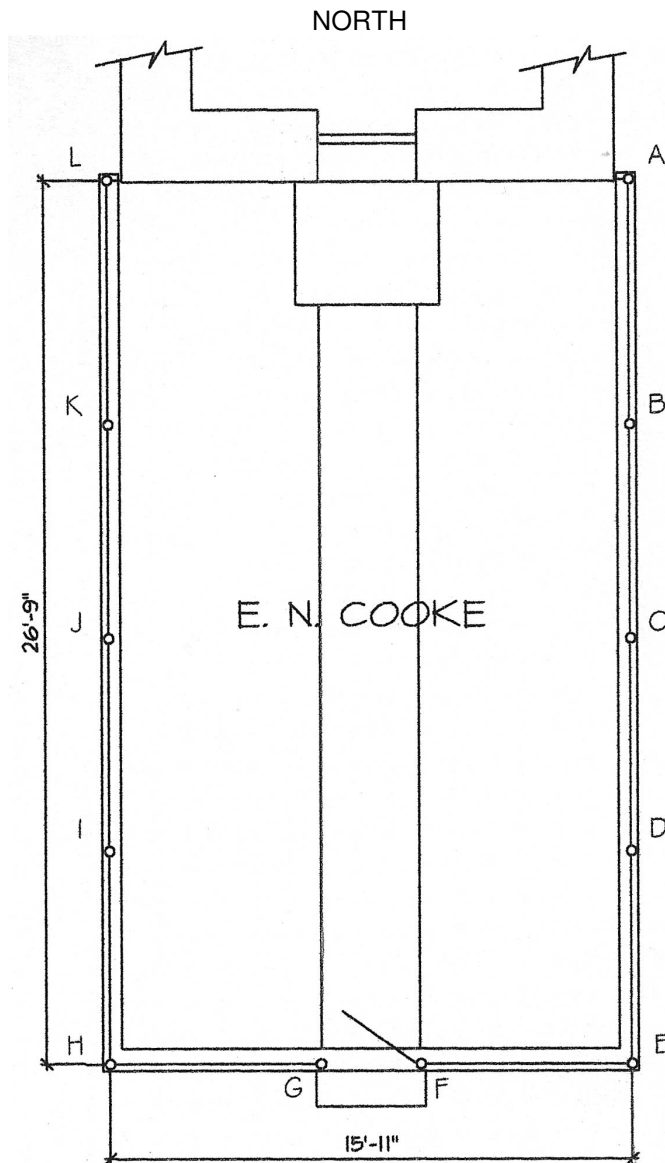
- The repair of the post anchorages is involved. Ideally the posts would be removed from the panel sections so that a new anchorage system could be designed and installed. The design of the anchorage to the stone should use non corrosive materials to avoid rust jacking on the stone. If there is prior rusted iron in the stone, it should be removed to limit future stone damage.

- The NE corner post 'A' is wobbly and does not have sufficient anchorage. The post is mounted close to the exterior face of the curbstone causing stress on the outer section of stone. This previously repaired curbstone that has a broken corner under the post needs new repairs, and the stone is out of alignment resulting in a 2" gap to vault wall. The repair needed is for mechanical anchoring of the broken stone corner using interior stainless steel anchors and new bonding, mortar or epoxy, of the broken piece to the stone. The stone should be reset in the dirt to align closely to the vault wall. An anchor at the top of the fence to the vault wall would reduce future stress on this repair.

- The SE corner post 'E' has an interior threaded rod that may or may not be original. It is not known how this rod is anchored to the curb, likely with an iron or steel rod set into the stone curb. There is a gap between the finial and the post body that allows water inside. The gap should be lessened as possible and the gap filled with a suitable, paintable caulking to deter water entry. It would be difficult to shorten the rod without disassembling the post.

- The west post 'G' at the gate latch has a horizontal crack in its cast iron at the top of the base portion that extends half way around perimeter. This post does not have an interior anchoring rod. The crack should be able to be repaired. If not welded continuously, gaps should be

- Stone Curb: All corners except the northwest have cracked stone bases, but are intact. This may be due to rust expansion from an interior iron support rod, or from forces on the fence that are transmitted to the curb. The posts are mounted close to the exterior face of the curb rather than being centered on the top, which reduces the amount of stone available to resist forces.
- Finish: Flat black paint has turned grey, but is intact and not rusting. Recoating is due.

filled with a suitable, paintable caulking. The gate posts receive stress from the gate's operation. A small discrete rubber bumper would lessen the gate's closing impact.
