METAL CRAFT REPAIR, TREATMENT AND
MAINTENANCE PLAN PROJECT

SALEM PIONEER CEMETERY

APRIL 20, 2018

A REPORT ON EXISTING CONDITIONS TOGETHER WITH NEEDED REPAIRS, TREATMENT RECOMMENDATIONS, & LONG-TERM MAINTENANCE GUIDANCE FOR THE CITY OF SALEM PARKS AND RECREATION SERVICES PUBLIC WORKS DEPARTMENT

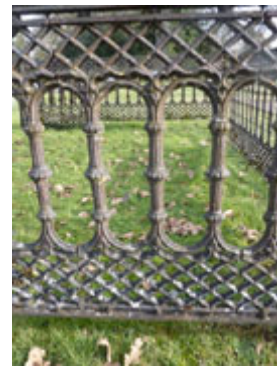
Typical Cast Iron Panel

- Replace (2) panels where indicated on diagram. These appear to be available and in stock from Lawler Foundry in Alabama; Pattern #8658.
- Posts A & D have base plates with portions broken off. These can be mended with newly fabricated material. Post A needs to be reinstalled.

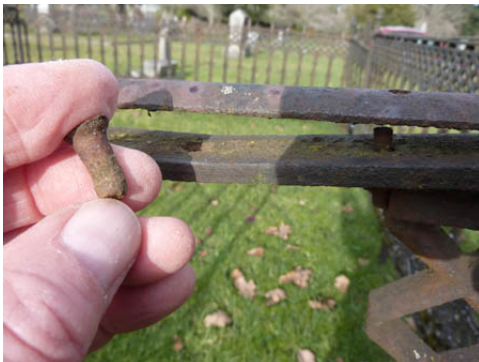
- Post and Rail Bolts: New bolts are required at various locations to secure the posts to the ground plates and for rails to posts after repairs are made. Approximately 75% of the small bolts on the rounded top rail piece are rusted out and need replacement. New bolts should be galvanized iron or stainless steel.

Countersunk Rail Fastener

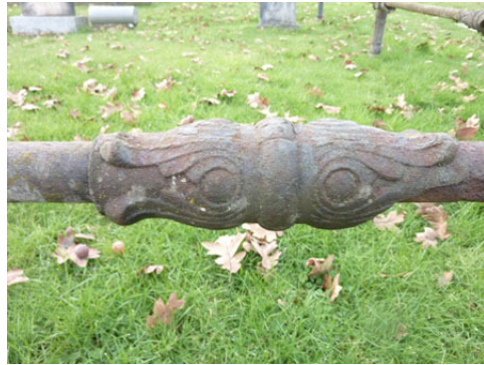
- Rail Sleeves: Many are broken or missing, 21 of 44 ends and 14 of 22 middles, as inventoried at the following bays:
 - AB: Ends: 3 broken; Middles: 2 broken

Middle Rail Sleeve Ornament

A source for the broken and missing sleeves or an appropriate mold pattern has not been located. New sleeves would need to be cast from new molds taken from intact pieces.

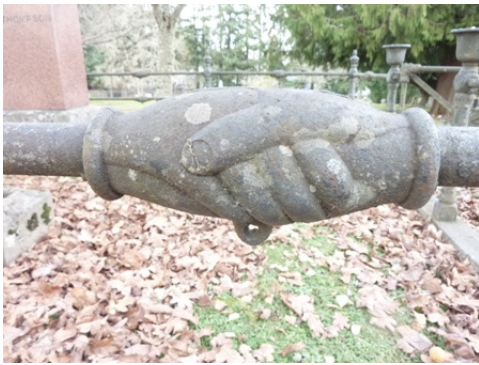
Middle Rail Sleeve Ornament

- The cost for new castings is expensive [see budget cost information from Robinson Iron]. To make new molds and cast the ornamental sleeve pieces would cost over \$6,500. Suitable replacement finials might be located rather than casting new members. The first priority is for the repair of post and rails, gate repairs, and refinishing. Total repair cost not including repainting or new castings: \$3,500.

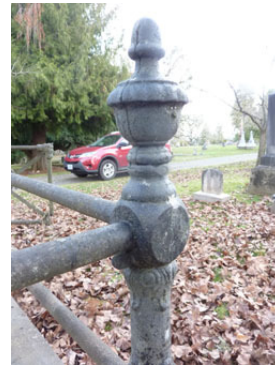
Typical Post Finial

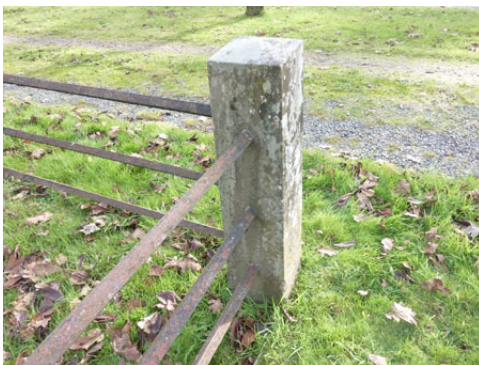
View of Post 'F'

- Middle FG rail is loose at Post G; Lower HJ rail is loose at Post H. The lead at these locations could be reworked to tighten those joints to make waterproof connections
- **Finish:** The posts are generally in good condition, and need only light cleaning if desired. The rusting on the rails appears stable. See alternatives in the materials discussion section.

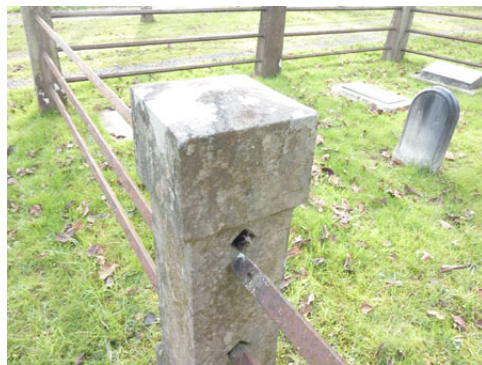
- **Wrought Iron Rails:** Rails are 1¼" square section set at 45 degree angle. The rails are set 11½" apart and are 7½" below the top. Rails are inset into the posts and secured with lead. Between Post B and Post C the top two rails are not set secure which allows them to be removed for access. Rails do not have their natural black wrought iron finish and are rusted, but the rusting appears to be stable and has not stained the stone.

View of Post 'C' with Removable Rails

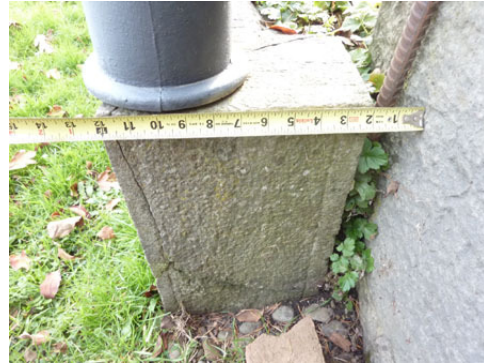
View of Misalignment at SE Corner of Vault
